# What is MGND

Keysight i1000 misreporting of failed card.  
Digital card is damaged but Analog card is reported as  
damaged instead.

## Introduction

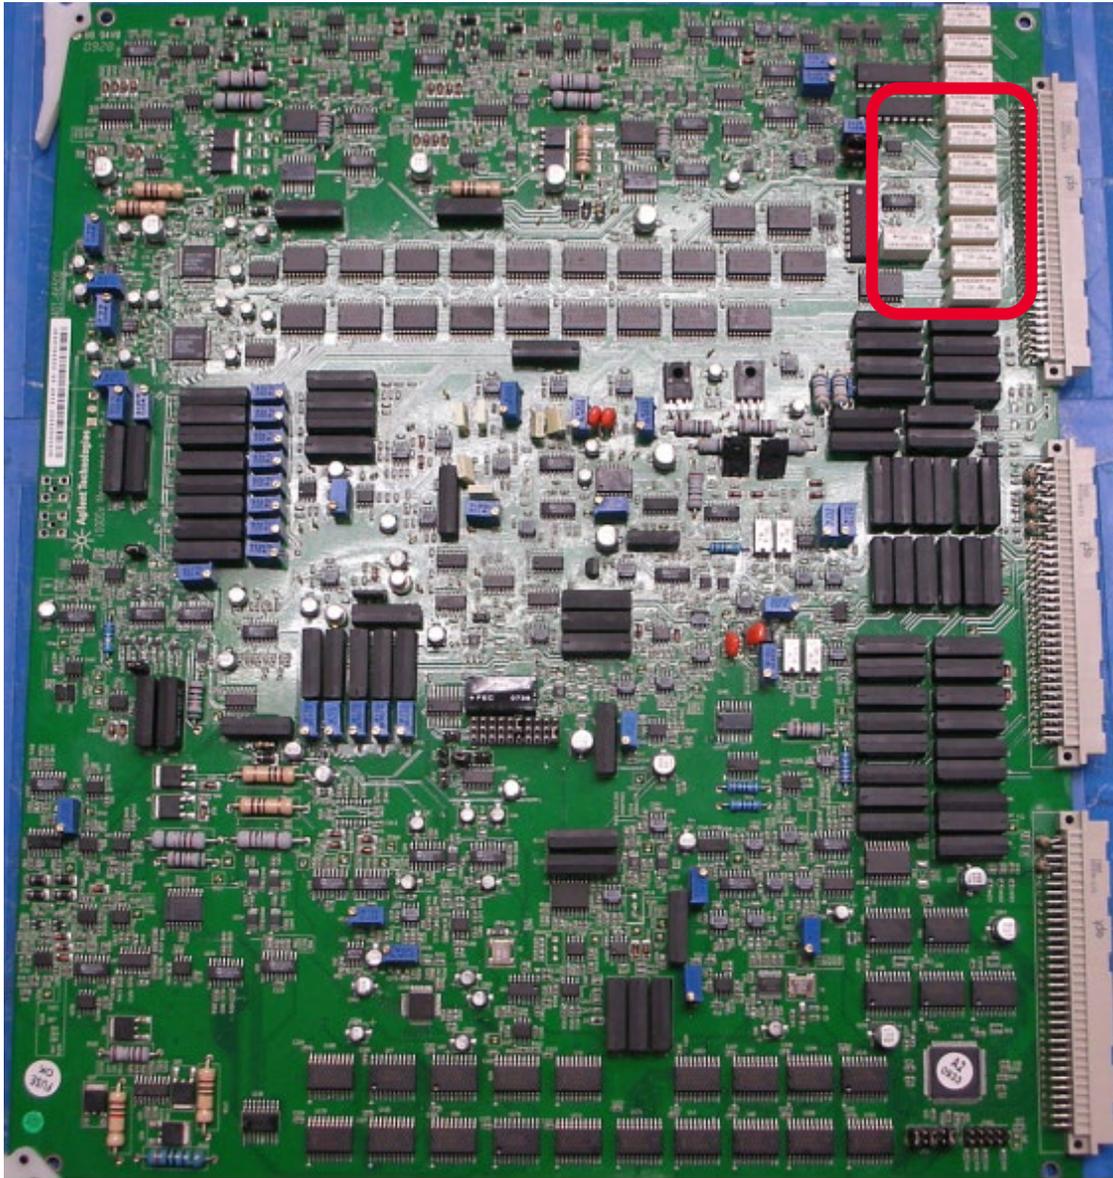
Figure 1-1: Measurement card with MGND

The MGND is a connected measurement card ground to system ground. The i1000 uses 8 sets of relays for its connections. As shown in the image below, the MGND relays are marked in the red rectangle.

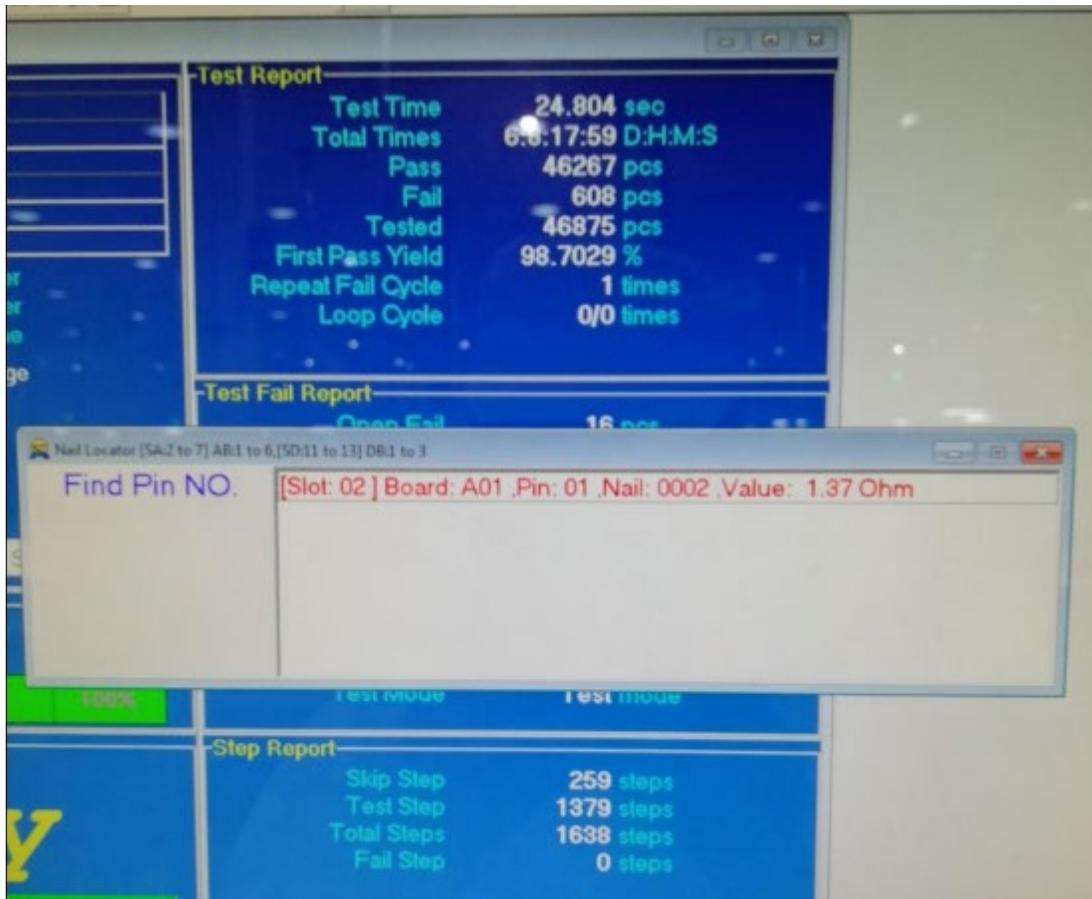
**Figure 2-2: Find Pin Window**

Experienced engineers may suspect the digital card to be the cause of this issue. The find pin window is launched (Alt + P hotkey) to probe. Although the find pin probe does not touch any test probe at this moment, but one node is displayed in find pin window as shown below:

Normally the find pin probe is connected to the system ground. If it is not touching any test probes, then nothing will be displayed.

In most cases, Nail 1 is the DUT board ground and all odd pins of the digital card are digital ground. Any time the DGND relay is stuck because of the board ground and digital card ground are connected to the ground plate, the board ground is then shorted to system ground via digital card ground.

User needs to use certain methods to identify the damaged digital card, such as dichotomization or by removing the digital cards one by one.

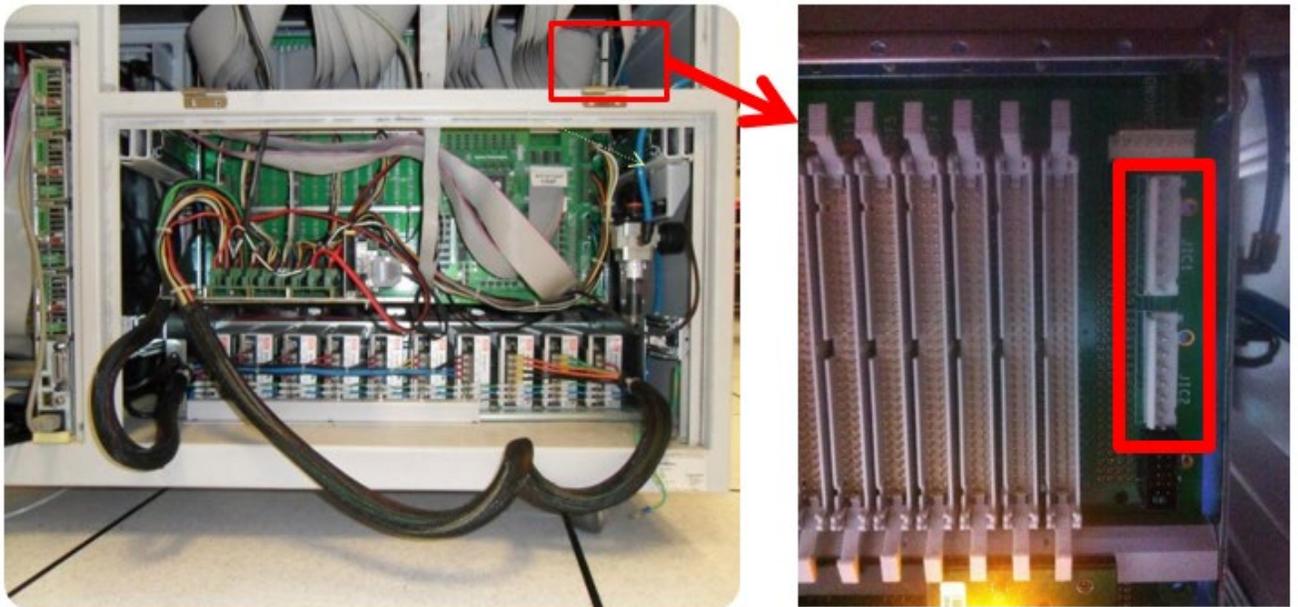
**Figure 3-1: i1000 Press Down System MGND Connector Location**

The i1000 Press Down type system must be manually connected to the MGND wire while exchanging each fixture. The two MDNG connectors are highlighted in the image below in the red rectangle.

Each connector has 8 pins, with a total of 16 pins.

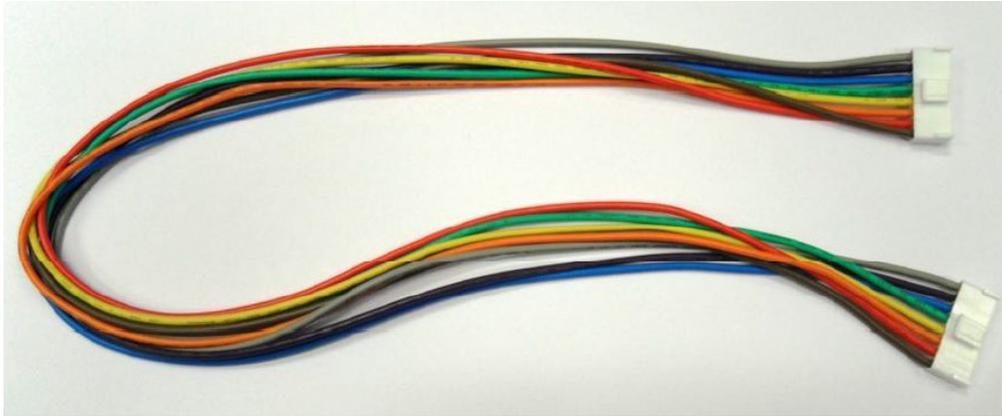
**Figure 3-2: MGND Cable**

An 8-Pin cable is shipped together with the i1000 system shown below. It should be connected between the i1000 system and fixture's MGND connector.

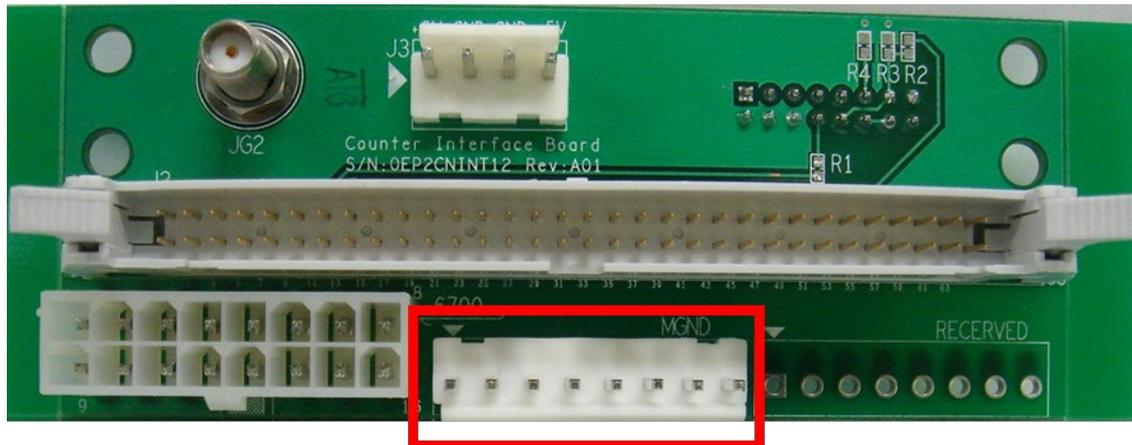
**Figure 3-3: MGND Connector on the fixture**

If the i1000 program needs to run power up test, the i1000 fixture must use Counter Interface Board. The MGND connector is highlighted in the image below with a red rectangle.

When building the fixture, the wire should be soldered to each pin of the MGND connector and each board's GND probes.

If the DUT board is a single board and it is not possible to solder all 8 pins together, then the wire can be soldered to the DUT board's GND probes.

If there is a panel board, each MGND pin should be soldered to each board's GND probes. If there are more than 9 boards in a panel, the 9<sup>th</sup> board's MGND wire should be restarted from the first pin of the MGND connector.

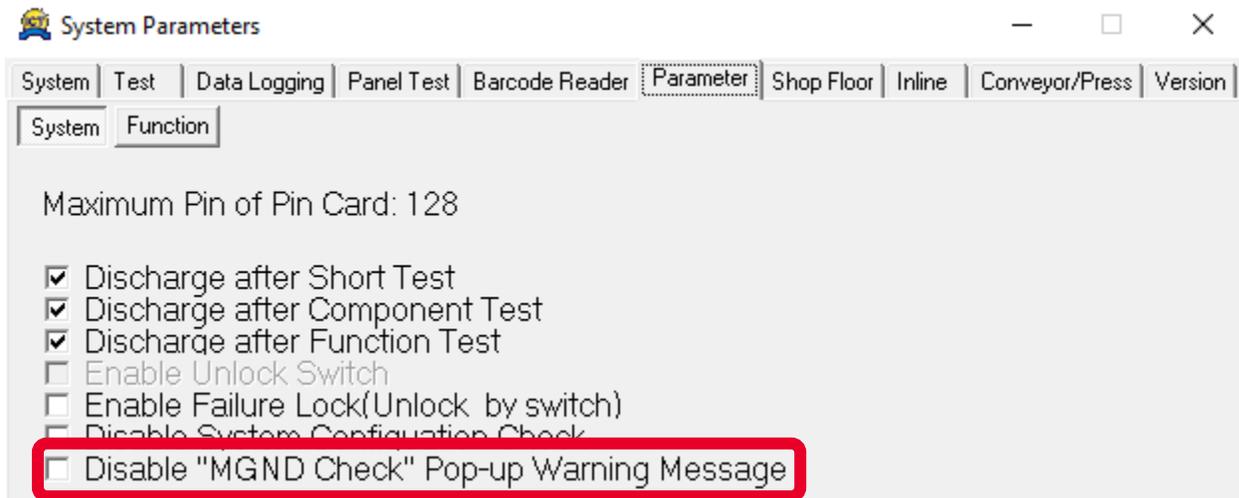
**Figure 4-1: Disable MGND Check Pop-up window**

Now, the i1000 software will close the MGND before closing the DGND while preparing to increase power. The i1000 software will also check if the MGND wire is available.

If the software has been upgraded to the latest version but the MGND wiring has yet to be added to the fixture, then you may temporarily skip the MGND checking function by disabling it as shown in the figure above.

Once the MGND wiring has been added, the MGND wiring checking function should be enabled.
