Keysight Technologies

Scanning Microwave Microscopy for
Semiconductor Failure Analysis

Application Note

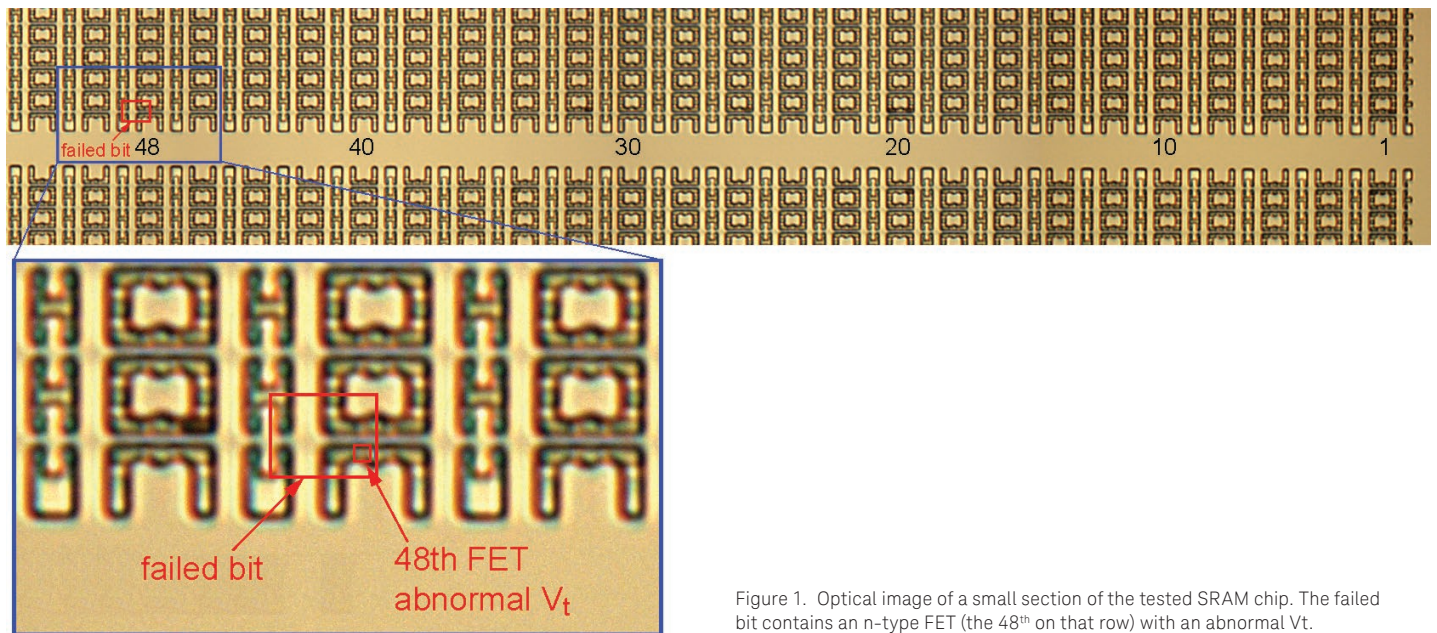
Figure 1. Optical image of a small section of the tested SRAM chip. The failed bit contains an n-type FET (the 48th on that row) with an abnormal V_t .

The sample being tested was a depackaged 250 nm static random access memory (SRAM) chip. A standard SRAM unit bit cell contains six field effect transistors (FETs), two p-type FETs in an n-doped well and four n-type FETs in a neighbor p well. Among thousands of bit cells on the chip, one failed. Inside the failed bit, one n-type FET was measured having an abnormal threshold voltage V_t . It was the 48th n FET on that row, as shown in Figure 1. Scanning microwave microscopy was tried, attempting to find any unusual properties of the transistor different from other normal transistors.

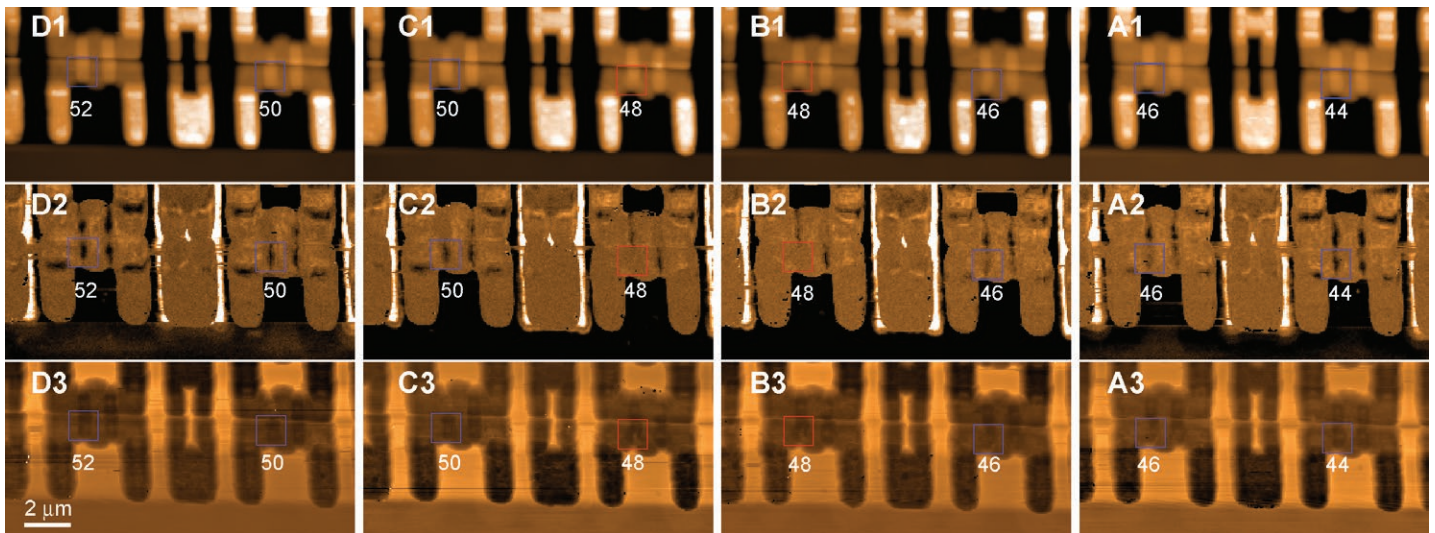
Figure 2. Four sets (A, B, C, and D) of scanning microwave microscopy images on the failed SRAM chip. Each set contains topography (top), dC/dV (middle), and VNA amplitude (bottom) images acquired simultaneously. The red squares outlined the failed 48th n-type FET, and the blue squares are normal n FETs on the same row.

To accurately identify any possible problem with sufficient details, every two pairs of FETs on the same row as the failed FET were scanned, from the 43rd/44th pair through the 51st/52nd pair, as shown in Figure 2. Total of four sets of images (A, B, C, and D) were acquired under the same conditions. Each set contained topography (top), dC/dV (middle), and VNA amplitude (bottom) images obtained simultaneously. For illustration purposes the even number n-type FETs on the same row as the failed FET were outlined with squares in all images.

The topography images of the 48th n FET, outlined by the red squares in Figures 2 B1 and C1, didn't appear to have any structural difference compared to the normal n FETs (blue squares as well as the unmarked ones in all of the topography images). They were also very similar to those seen on other SRAM samples [2, 4]. In the dC/dV images, however, the difference was quite noticeable. Every normal n FET (blue square) consistently showed a dark area near the center. The dark (low) value in the dC/dV image represented p-type dopant of the well in the channel. The 48th n FET, on the other hand, was completely flat without any contrast, as shown in the red squares of both Figures 2 B2 and C2. The missing p-dopant signal in the 48th n FET clearly indicated a change of dopant structure of the channel area of the transistor. The VNA amplitude images of the 48th n FET, when examined carefully from Figures 2 B3 and C3, also showed a different structure from the other normal n FETs. It indicated a different capacitance/impedance value.

Scanning microwave microscopy has demonstrated its capability of doing semiconductor failure analysis. Images of dopant concentration measured from the dC/dV signal on a defect SRAM chip clearly identified an unusual dopant structure of the failed n FET, different from other normal n FETs. Capacitance images measured from the VNA amplitude also showed a slight different contrast of the transistor. This experiment has shown that the scanning microwave microscope can be a convenient direct-imaging tool to probe a variety of electric failures in semiconductor devices not visible from surface topography structure on scales of micrometers to nanometers.
